George P. Coleman Memorial Bridge Yorktown / Gloucester Point, VA

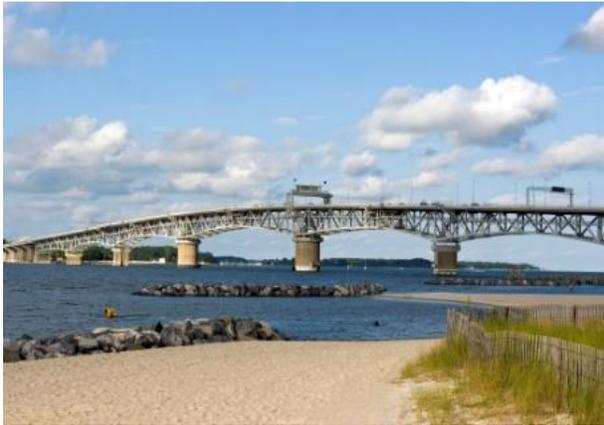
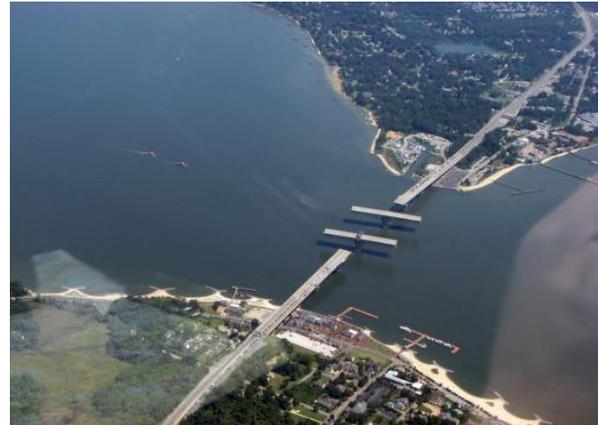
This major steel deck truss crossing the York River at Yorktown, VA, includes two 500 ft long swing spans. Lightweight concrete was used for the decks on the truss spans, which were constructed on falsework in Norfolk, VA, then barged as completed units to the site for erection. The lightweight concrete decks were cast in removable forms. Installation of the truss bridge segments was completed in a single nine day closure. Normal weight concrete was used for the decks on the approach spans (Castrodale&Robinson 2008).

While this project was a rehabilitation project, it involved the complete replacement of the superstructure. The main truss spans of this bridge were replaced and widened. Lightweight concrete was used in the bridge deck of the new structure to reduce the weight of the deck, resulting in a reduced quantity of steel required for the trusses. With the reduced superstructure weight, the existing piers could be widened without requiring the driving of additional piles. Lightweight concrete had been used successfully for decks on other bridges in Virginia, so the DOT was open to its use on this major crossing. The same specification was used for the lightweight concrete deck as the standard VDOT normal weight concrete deck, with the exception of a higher concrete compressive strength (4,500 psi instead of 4,000 psi) to account for the reduced shear capacity of the lightweight concrete and a density of 115 pcf (Abrahams 1996).

The lightweight concrete deck on the truss spans was ground as required to achieve the desired roadway profile and rideability, then transversely grooved for skid resistance. This work was completed prior to final erection of the trusses to make possible the rapid opening of the bridge to traffic. The surface of the deck remains exposed to traffic.

During a visit to the bridge in 2005 by one of the authors, no cracks were visible on the top or underside of the lightweight concrete deck. However, the normal weight concrete deck on the approach spans, which was conventionally constructed on site, had suffered from significant transverse cracking at an early age and had been repaired. It was learned from a VDOT inspector familiar with the bridge that the lightweight concrete deck had performed better than the normal weight concrete deck. It should be noted, however, that the conditions for placing the two types of concrete decks were probably different, which may have affected the performance of the decks (Castrodale&Robinson 2008).
